Rich Passage Long-Term Beach Monitoring
**MAY TO NOVEMBER 2017 BEACH RESPONSE
MONITORING REPORT**

Kitsap Transit
March 01, 2018

**Rich Passage Long-Term Monitoring
MAY TO NOVEMBER 2017 BEACH RESPONSE
MONITORING REPORT**

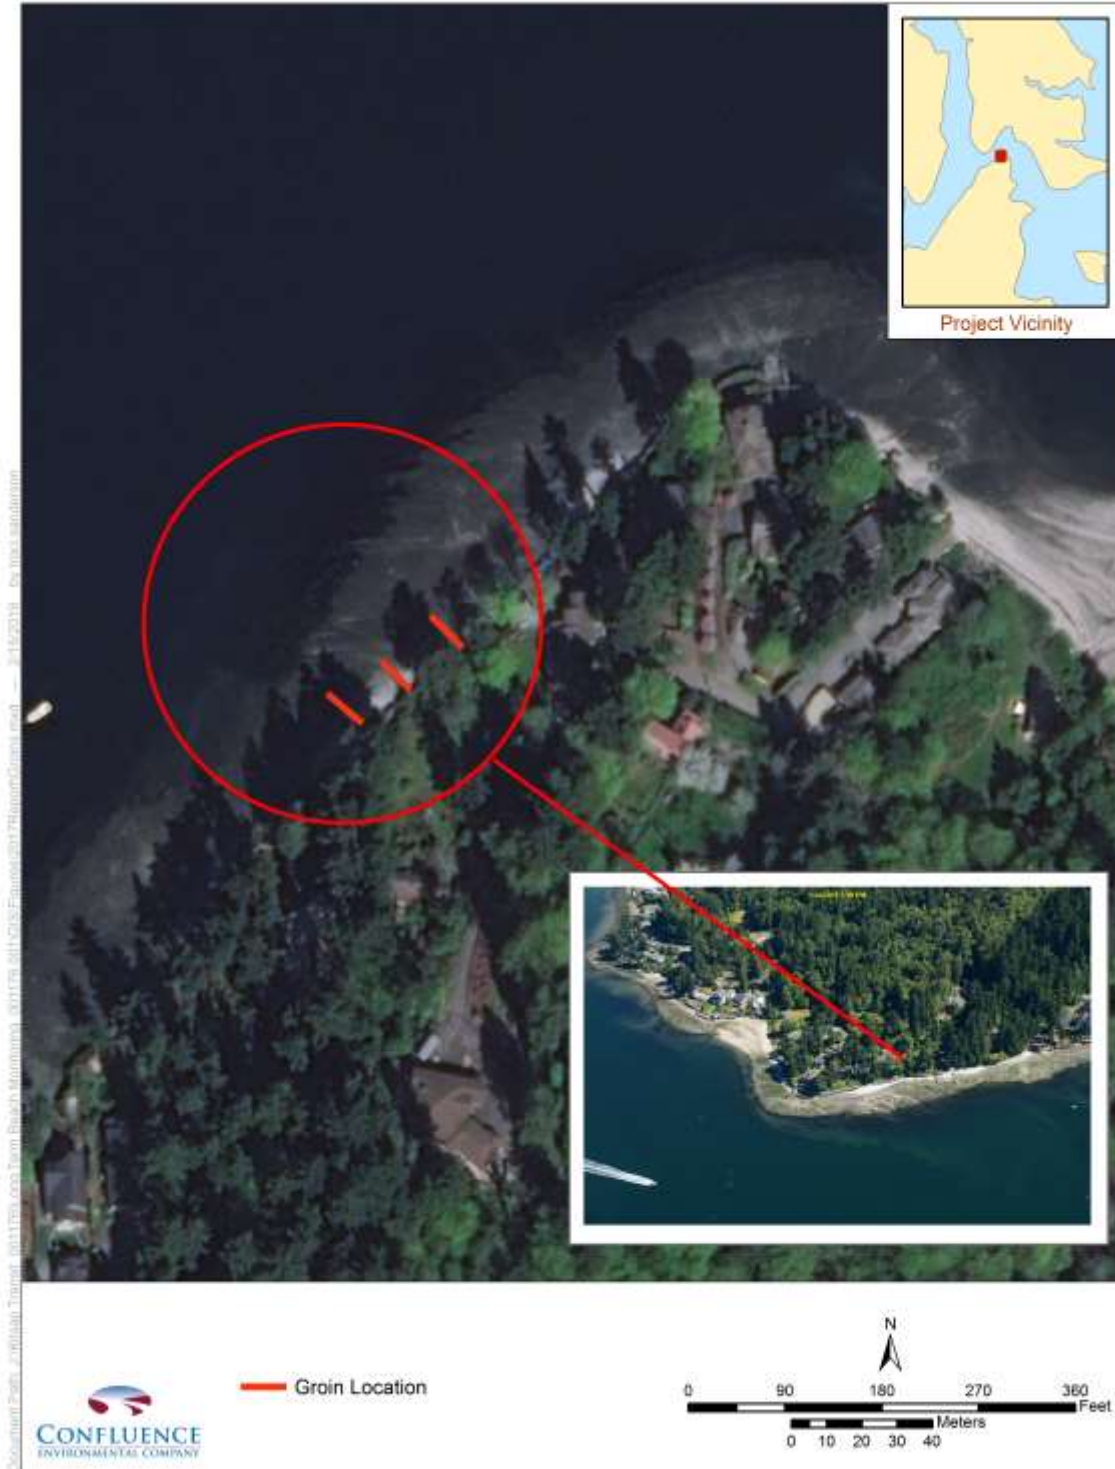
Figure 5. Location of groin structures on Point Glover.

The changes in beach elevations within the pocket beaches of Point Glover vary from beach to beach dependent on local effects. The sediment within the pocket beaches on the west side of Point Glover tends to shift back and forth seasonally due to wind-waves in the winter and vessel wakes (from all size and class of vessels) in the summer. Sediment movement along the west side of Point Glover is limited by the bedrock outcrops and to some extent by groins (stacked rock placed in a line perpendicular to the shoreline). These groins have been present in this area since at least 1992, based on imagery available from the Department of Ecology. The bulkhead was constructed in 1952, based on Kitsap County parcel information, and it is likely the structures were built at that time (Figure 5).

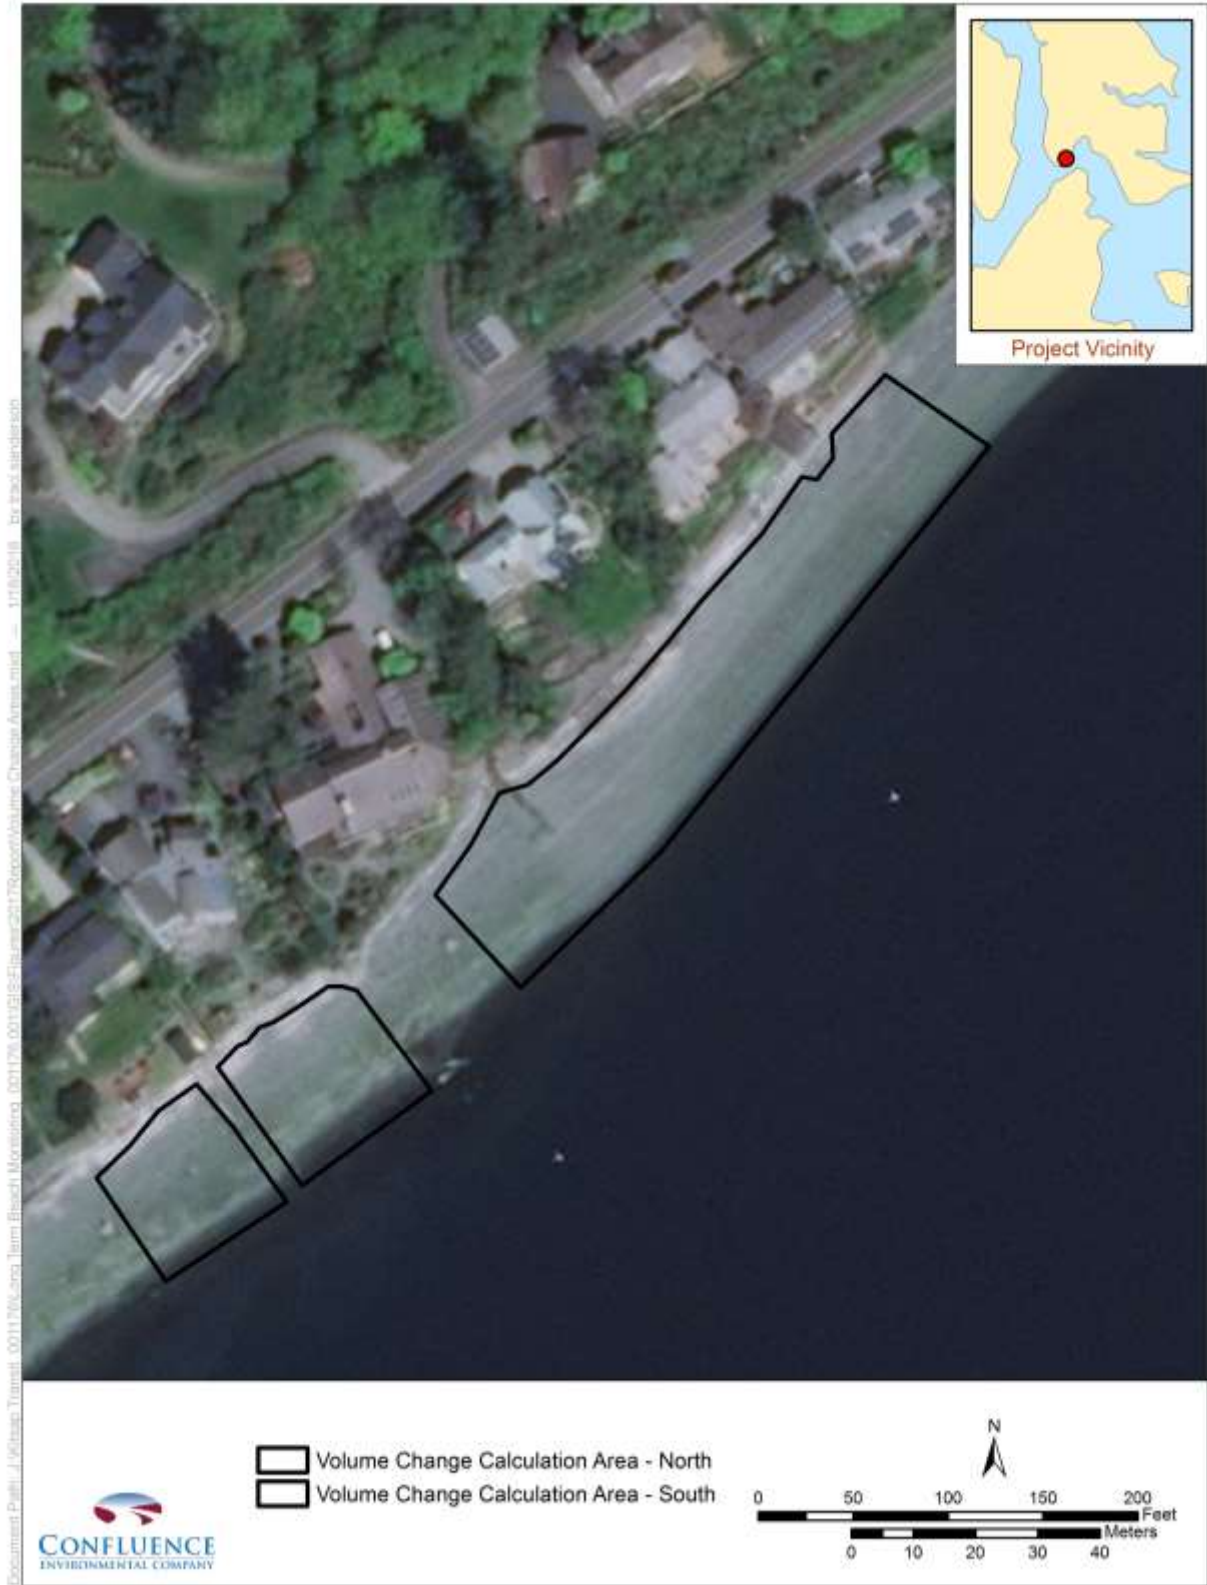
Figure 10. Point White volume change calculation area

The magnitude and spatial extent of the erosion and accretion patterns along Point White vary from year to year, so further analysis was conducted to calculate the total volumetric change within two subsets of the survey area (Point White North and Point White South [Figure 10]). The results of this analysis are shown in Tables 3 and 4, where a positive number indicates net increase in volume within the calculation area and a negative number indicates net decrease in volume. The total beach volume change between May and November 2017 was nearly equal to the total beach volume change between May and October 2014: a net decrease in beach volume of 63 CY in 2017 as compared to 70 CY in 2014 at Point White South and a net decrease of 81 CY in both 2017 and 2014 at Point White North. The smallest volume of beach change of -17 CY at Point White South and -35 CY at Point White North was measured from May to October 2014.

The volume change analysis indicates there is a net decrease in the volume of sediment within the calculation areas during each of the four summers. A similar analysis will be conducted after the May 2018 laser scanning surveys are completed to determine if the sediment is being deposited outside the calculation area and is transported back into the calculation area during the winter. Although there is a net loss of sediment between May and November 2017, this pattern is similar to previous years and, therefore, there is no measurable beach response along Point White in summer 2017 that can be directly attributed to RP1 operations.
